Final Report

Tornado Damage Investigation

Greensburg, Kansas

1699 DR-KS

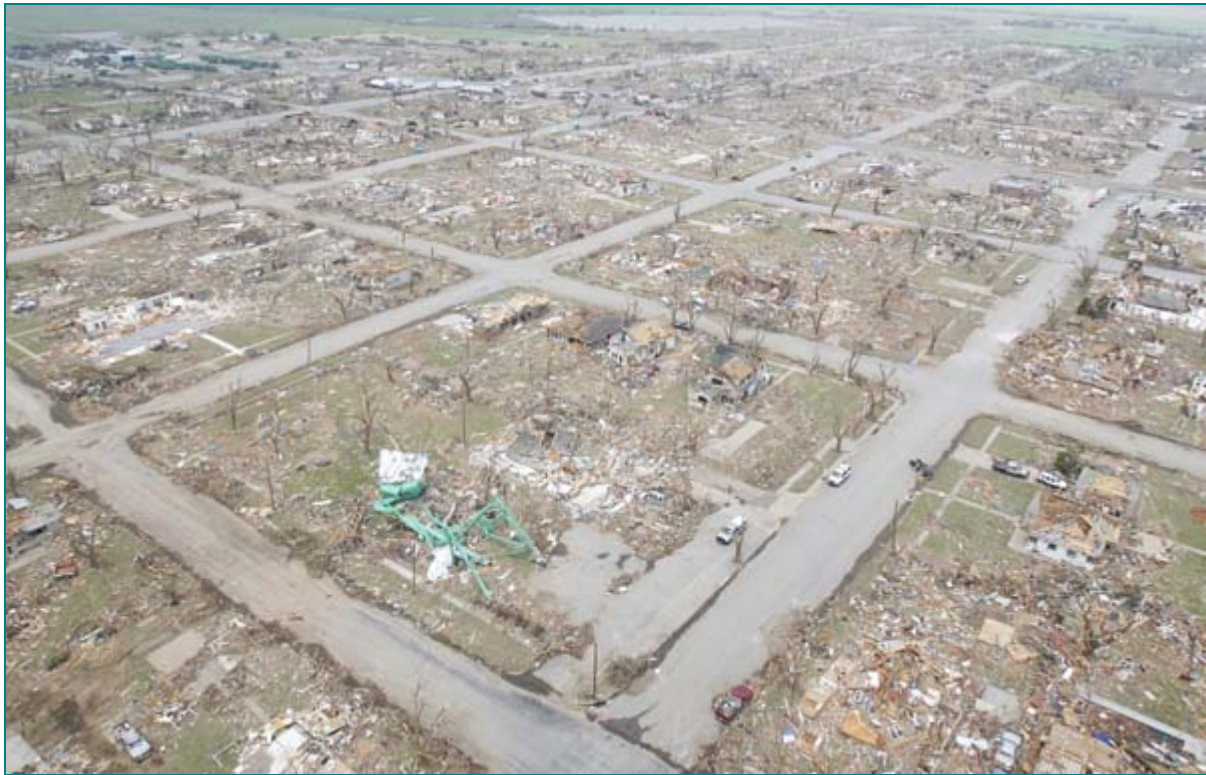
Figure 1: Greensburg, KS, after May 4, 2007 tornado event

1. The primary site observations were obtained from an initial study of overhead imagery and initial site inspections conducted on May 10-11, 2007:
 - a. The most severe swath of damage through the center of town was approximately five to six blocks wide. The damage on either side of this swath was less for about one to two blocks on each side, with even less damage observed for another one to two blocks on the extreme outer edges of the damage swath. See Figure 1 for an aerial view of Greensburg after the event and Figure 8 for a map of the damage swath.

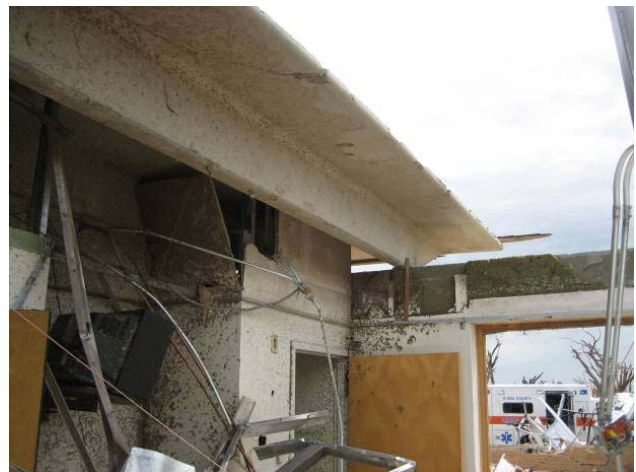
Figure 6: Hospital with Precast Concrete Twin Tees

The hospital is located north of Garfield Street and between Grove and Walnut Streets. The hospital roof was flat and framed with precast concrete double tees 40 inches wide and spanning 34 feet with 3-foot overhangs on each end (Figure 6). The precast concrete tee was calculated to weigh 9,979 lbs. There was an additional 15 psf of roof covering (roof felts and gravel ballast) on the roof at the time of the tornado strike. The precast concrete tee was not attached at all to the wall; it was only resting on the wall and held in place by gravity. The failure mode was the precast tee lifted off the hospital walls and was moved 80 feet from its original location on the roof. It is uncertain how the concrete tee reached this location. It could have tumbled across the roof or been picked up and thrown.
